BUILDING SCIENCE SERIES 40

Engineering Aspects of the 1971 San Fernando Earthquake

This report presents the observations of the NBS on-site inspection team (most photographs in this report were taken by the team). The material presented herein is intended to serve as (1) a documentation of damage resulting from the earthquake and (2) as a source document for further studies, research, and recommendations. This is particularly important as necessary remedial work and restoration have resulted in the removal of evidence that is essential for studies and evaluations.

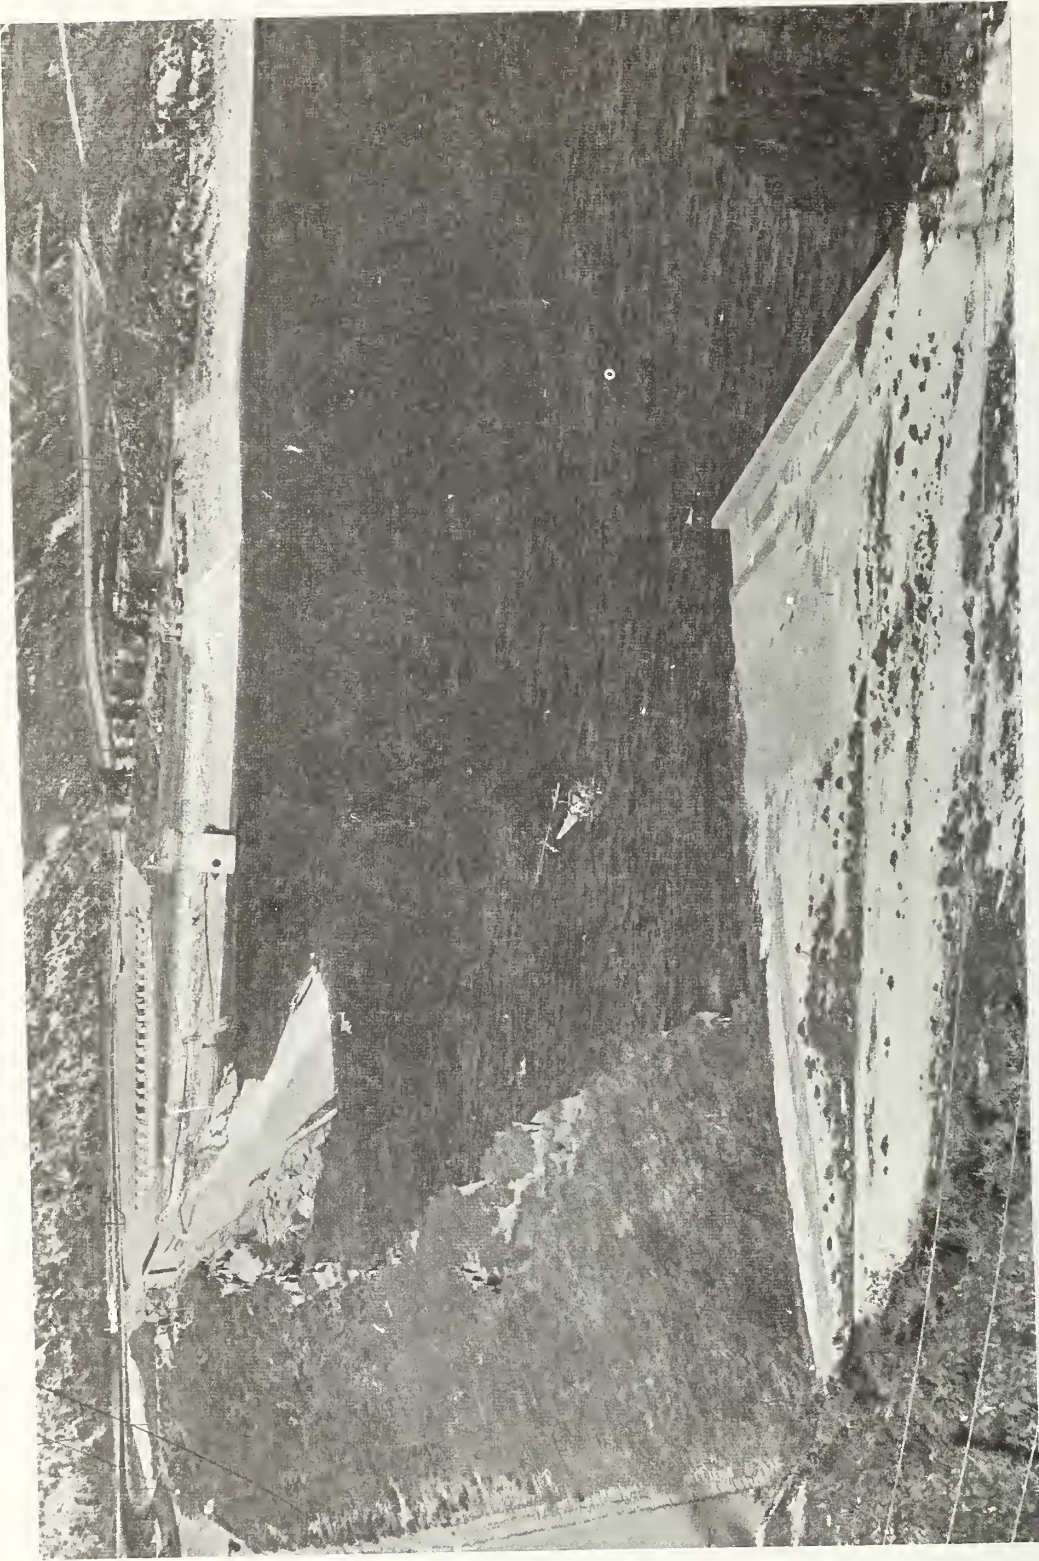
With regard to the failure of the dams as a result of the earthquake, there is a possibility that the failure was due to liquefaction of the material which was placed by hydraulic methods. In the hydraulic fill technique, a pipeline is used to transport soil-laden water to the dam site. By appropriate placement of parallel pipelines, the

Figure 4.3 Lower San Fernando Dam immediately after quake.

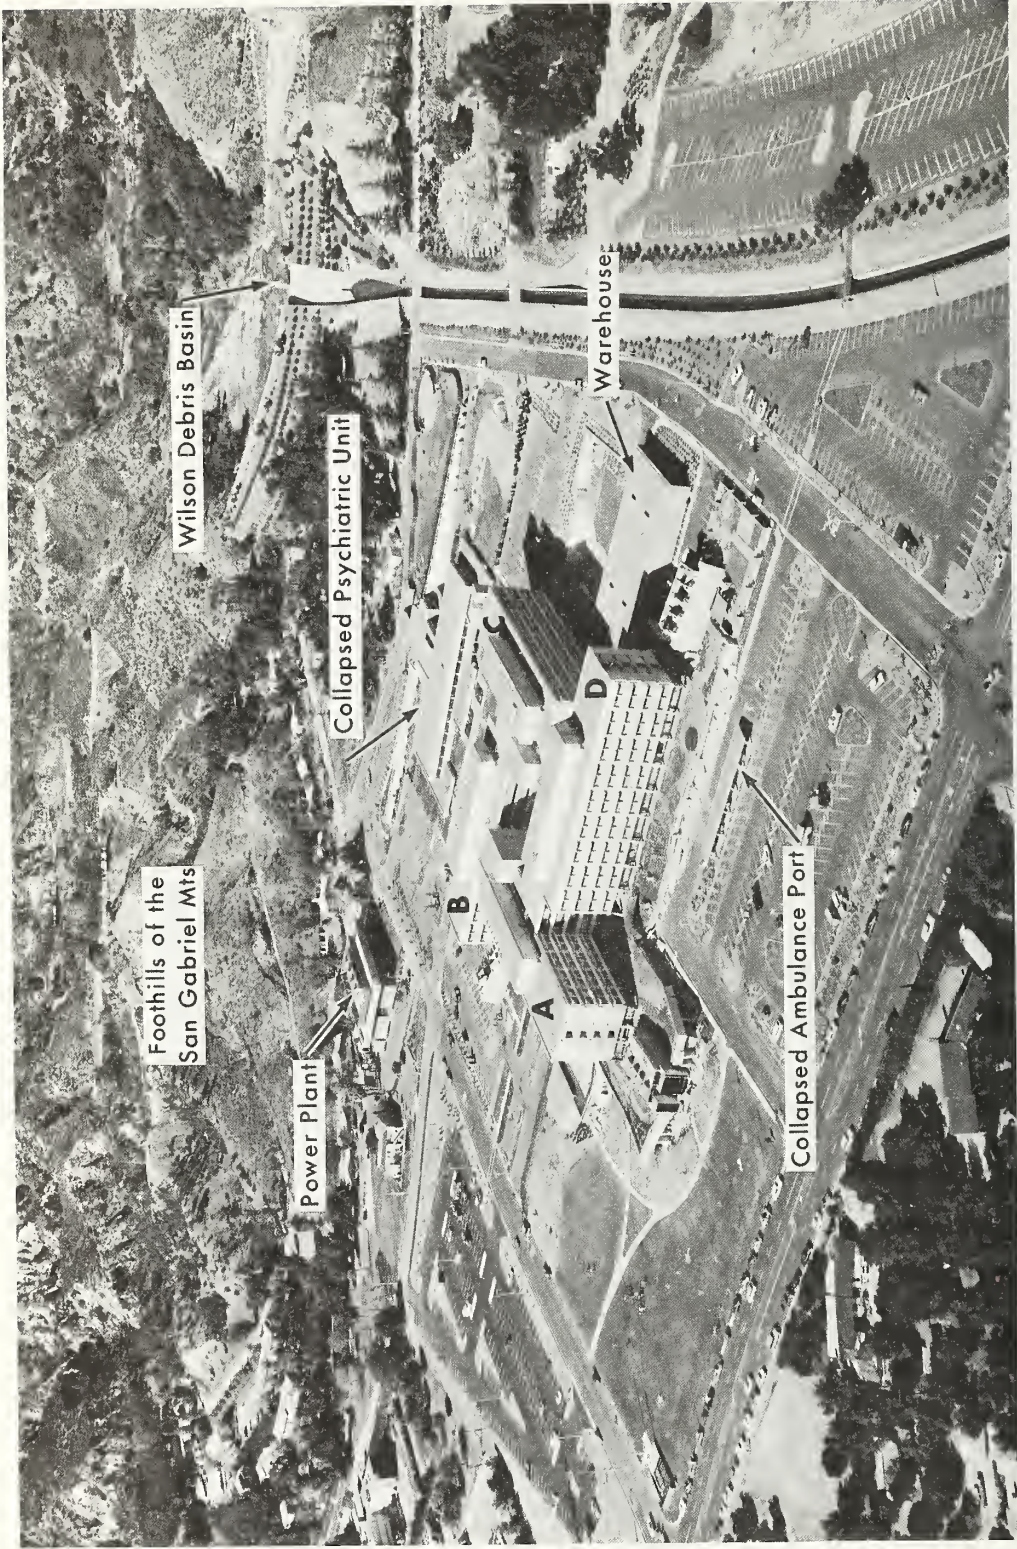
Figure 5.6 Olive View Medical Center after the earthquake, as viewed from the southeast (Los Angeles County Engineer Photo).

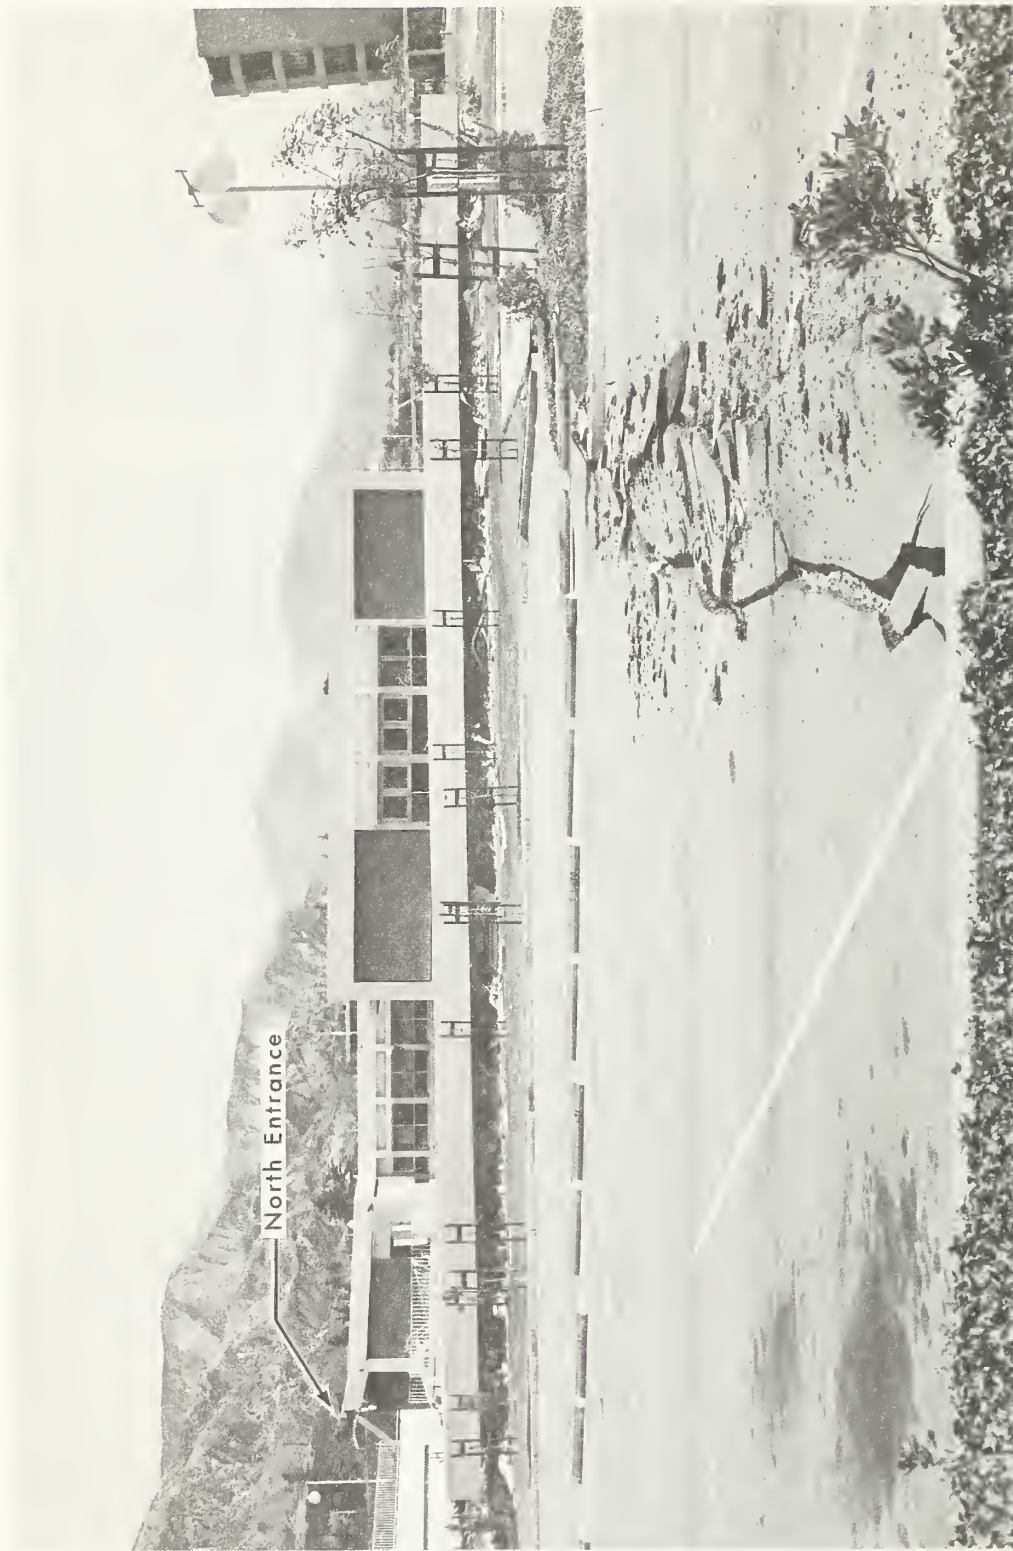
Figure 5.12 West elevation of the Psychiatric Unit.
Damage to the surface of the parking lot,
just west of this building, indicates
severe ground movement.

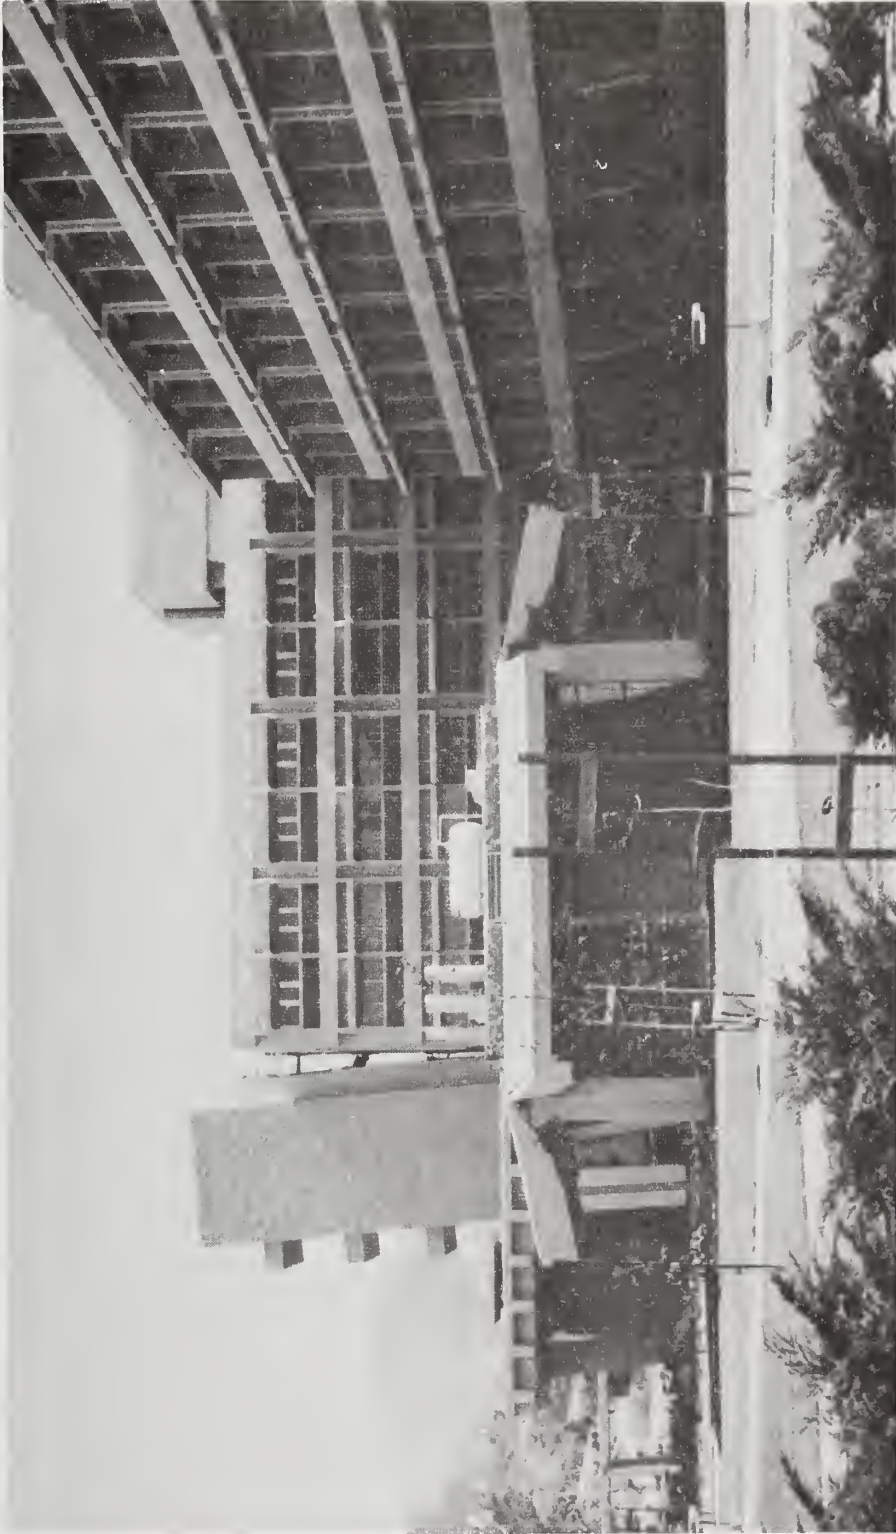
Figure 5.37 The damage to the overhanging canopy of the exhaust pavilion possibly indicates large vertical accelerations.

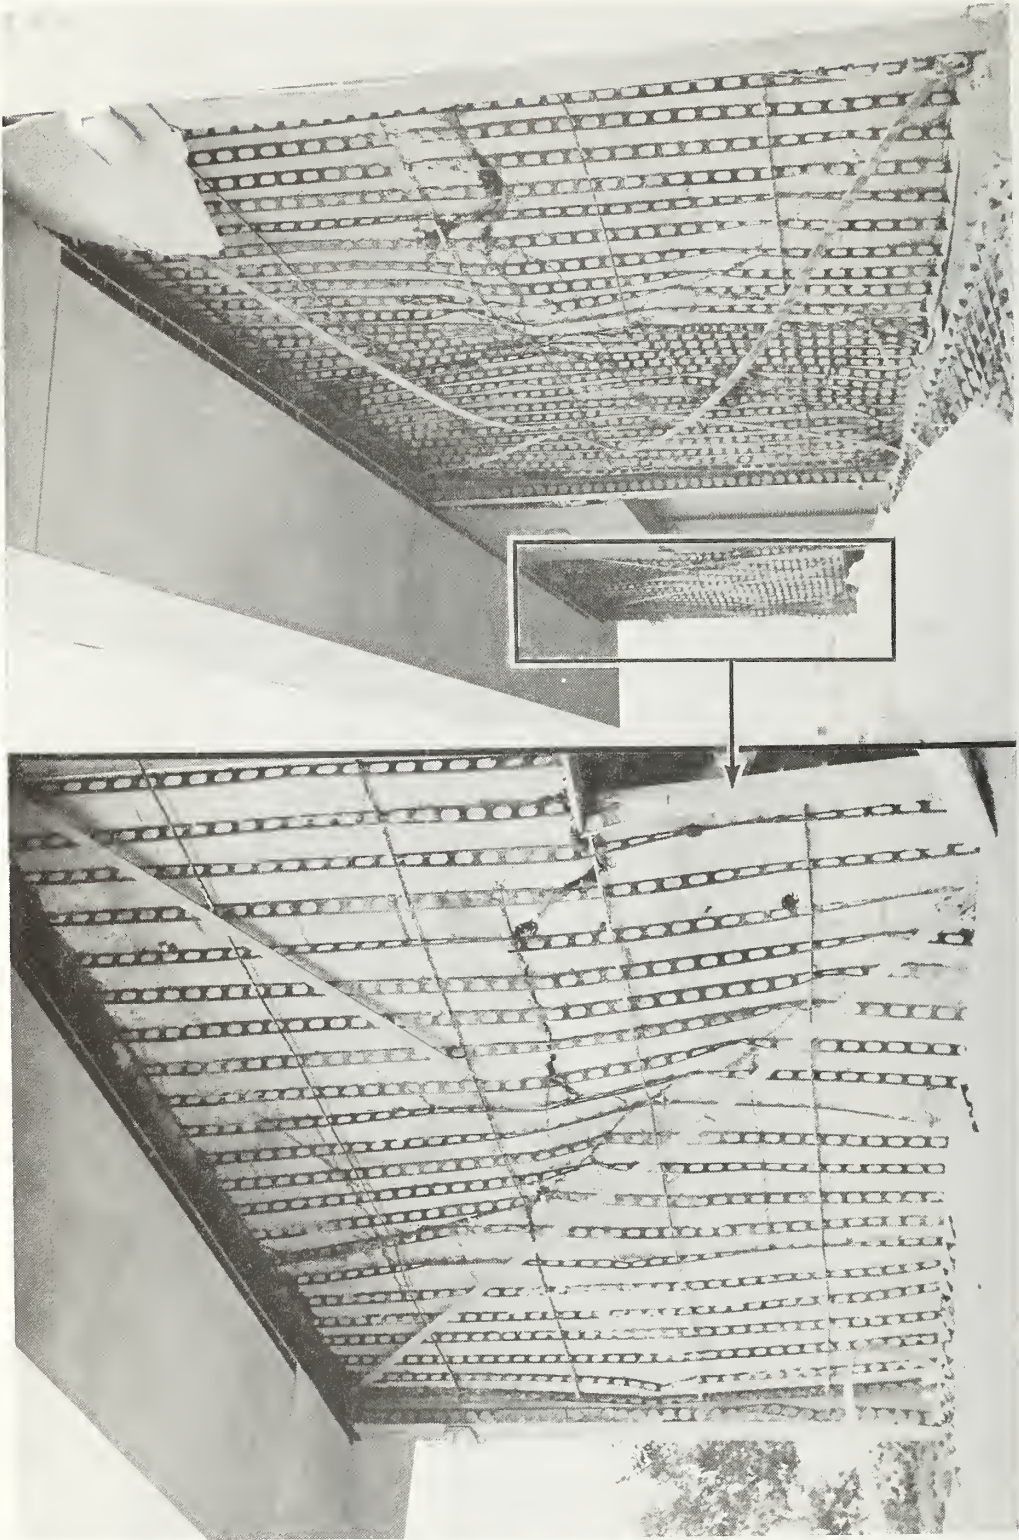
Figure 5.38 Damaged diagonal bracing in the north wall of the power plant.

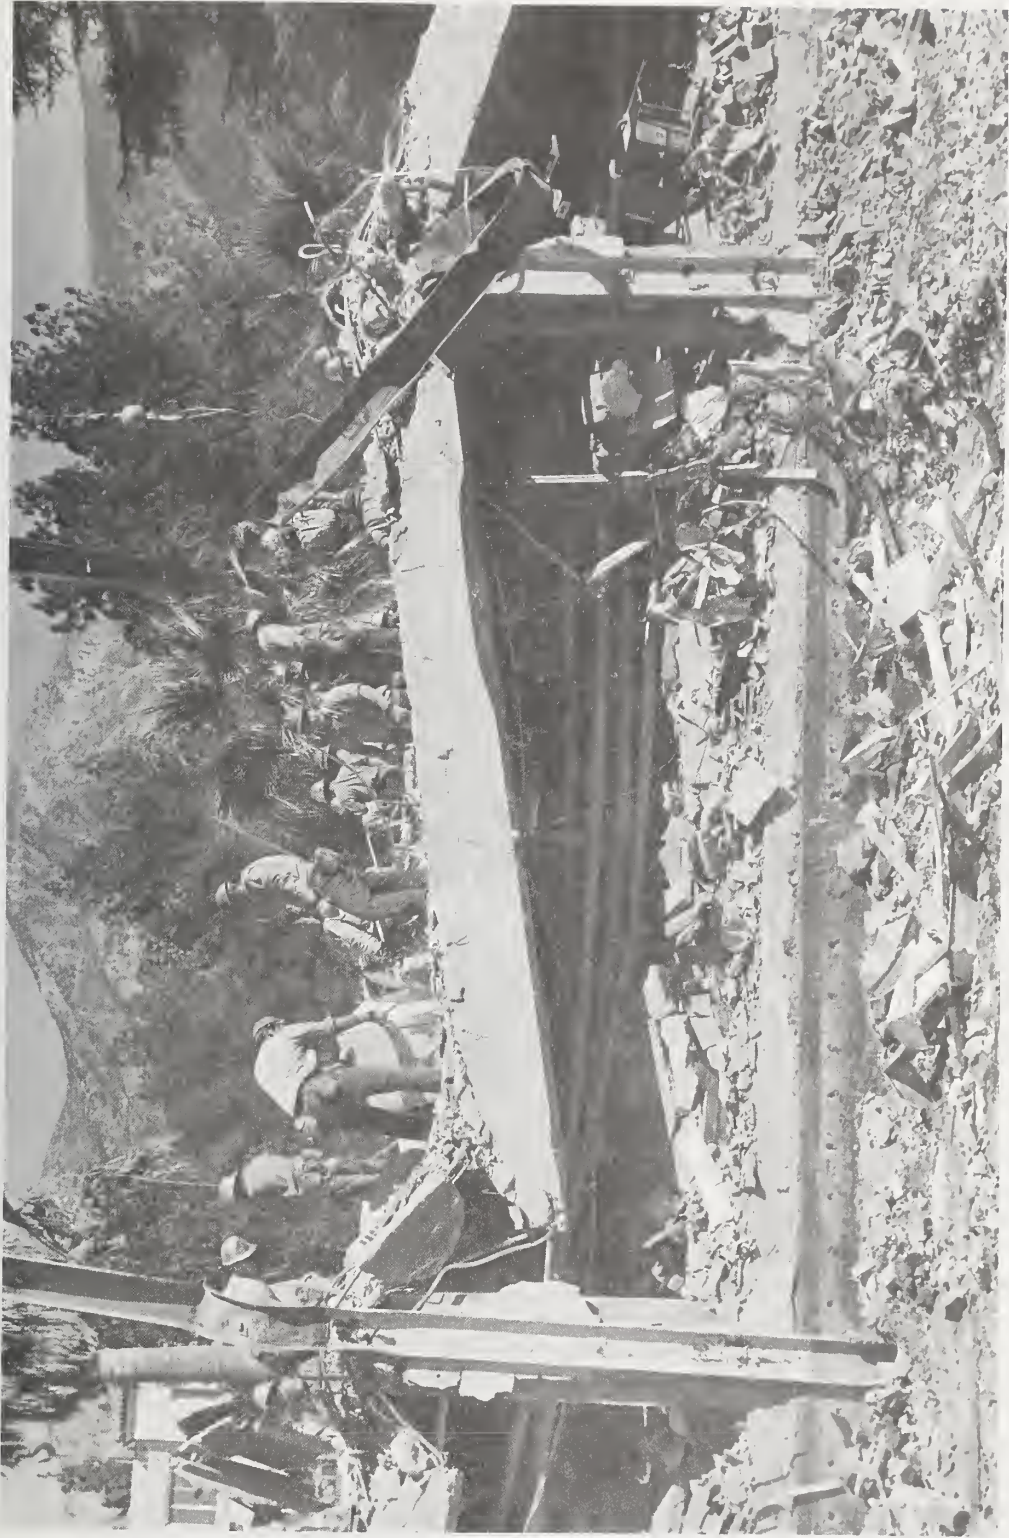
Figure 5.42 Rescue and clean-up operations. This collapsed building was constructed in 1925 and is a reinforced concrete frame structure infilled with unreinforced clay tile walls. (Los Angeles Times Photo).

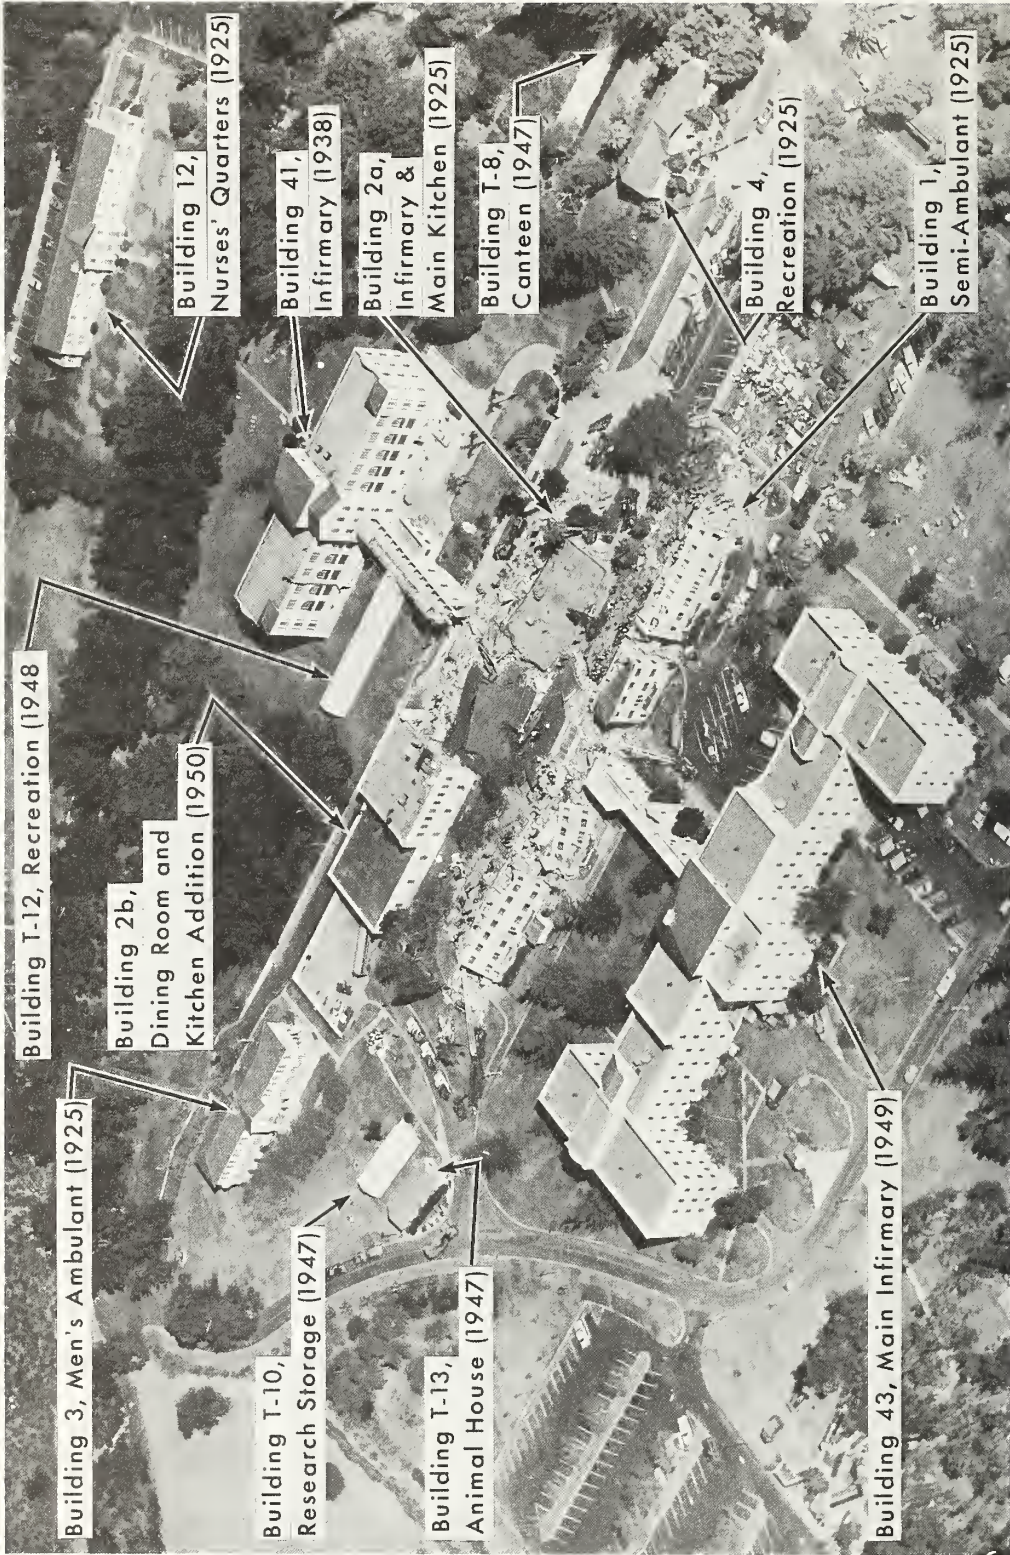
Figure 5.44 Collapsed buildings (No. 1 and 2a) constructed in 1925 where 46 patients and hospital workers were killed. Many of the buildings, also constructed in 1925 (Buildings 3, 4, and 12), although still standing, were severely damaged. (Los Angeles Times Photo).

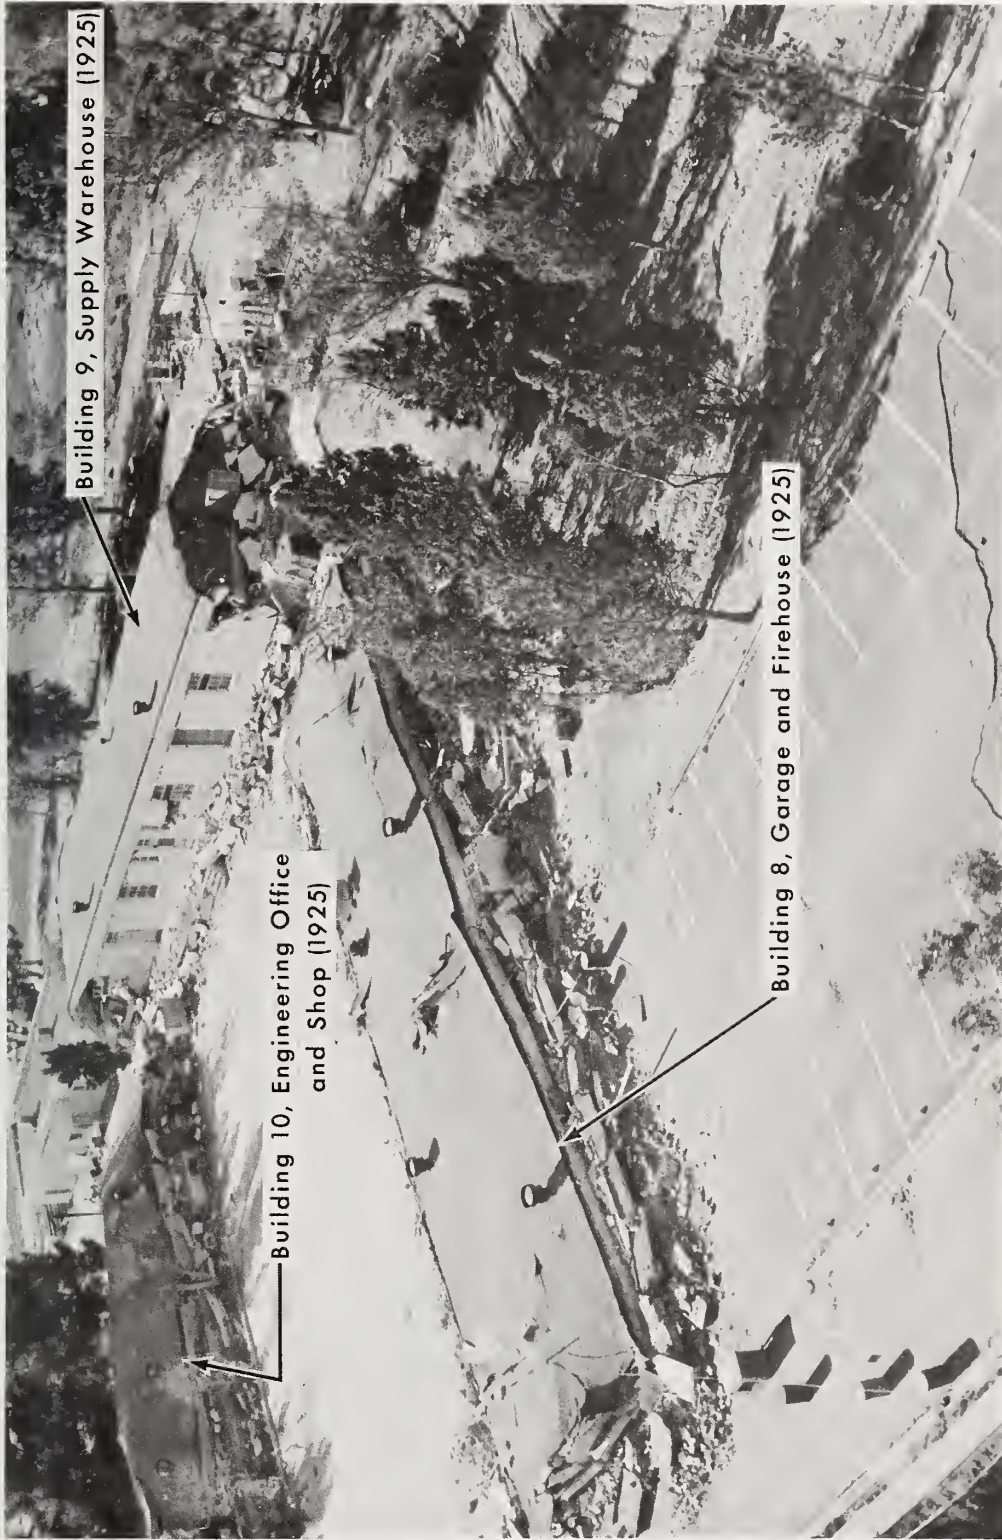
Figure 5.45 Collapsed one-story buildings (No. 8 and 10) located at the east end of the hospital complex. Note that two structures oriented in one direction collapsed; whereas, the building (No. 9) oriented 90 degrees to them is damaged but still standing.

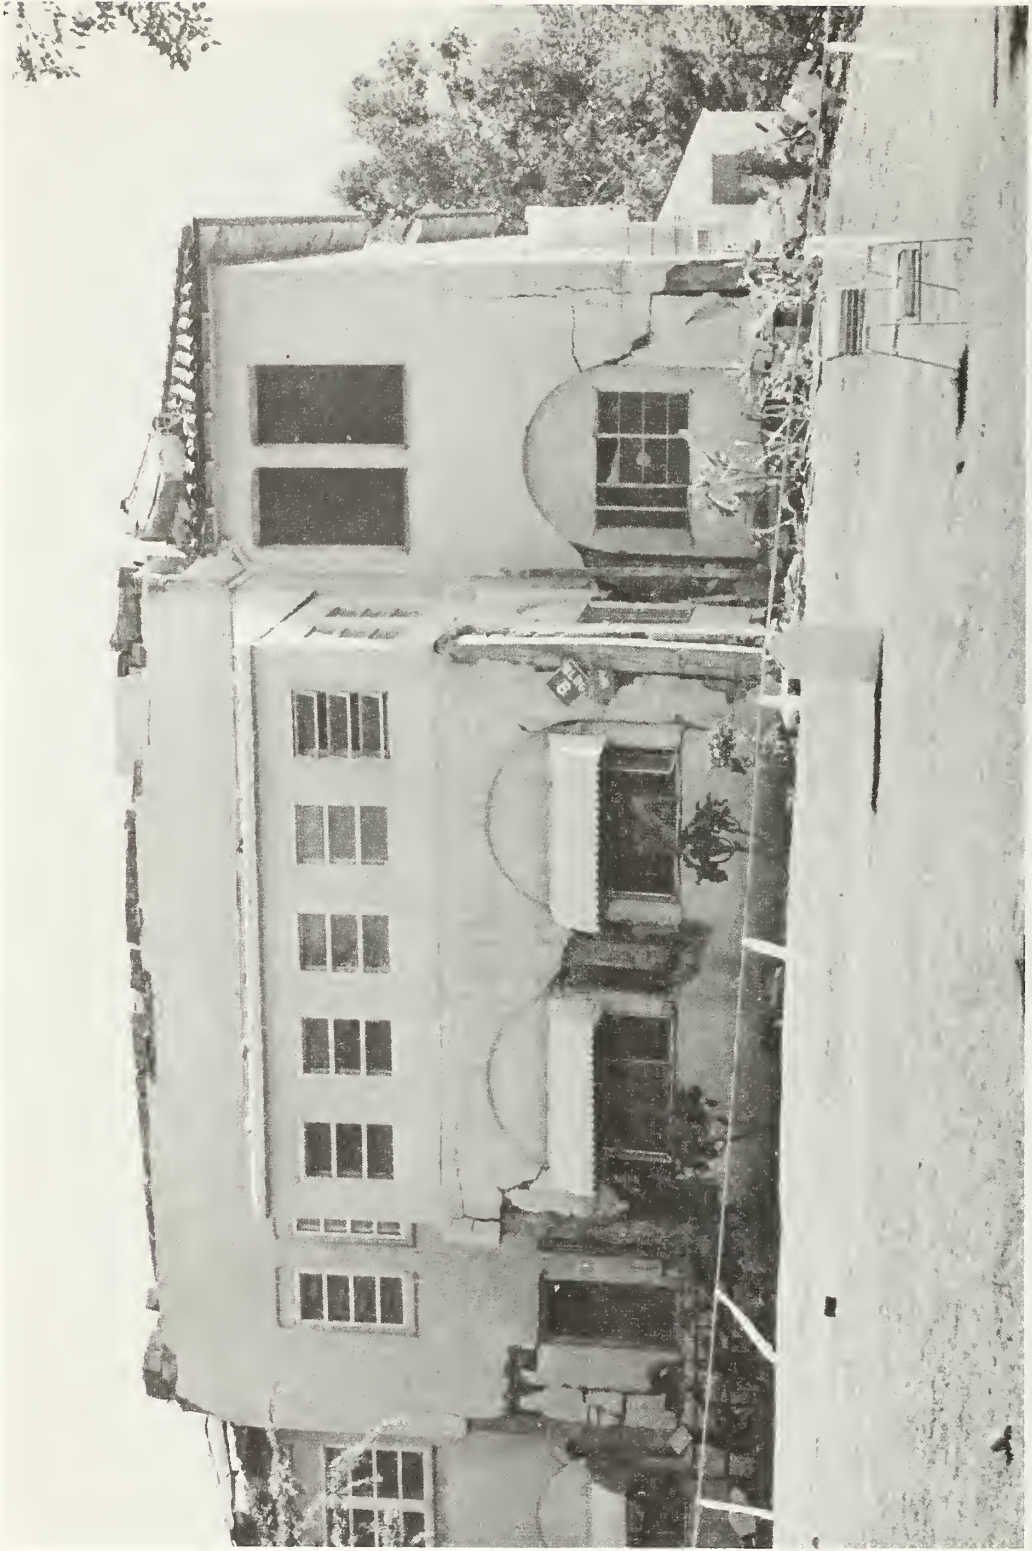
Building No. 6, a two-story building approximately 50 ft by 100 ft in plan, was one of the original 1925 buildings which was severely damaged (figs. 5.48, 5.49 and 5.50). A small one-story wood frame building (Building No. T-7) constructed in 1947 adjacent to Building No. 6 suffered no apparent damage.

Figure 5.48 Building 6, located east of the main buildings. This building which was constructed in 1925 was severely damaged.

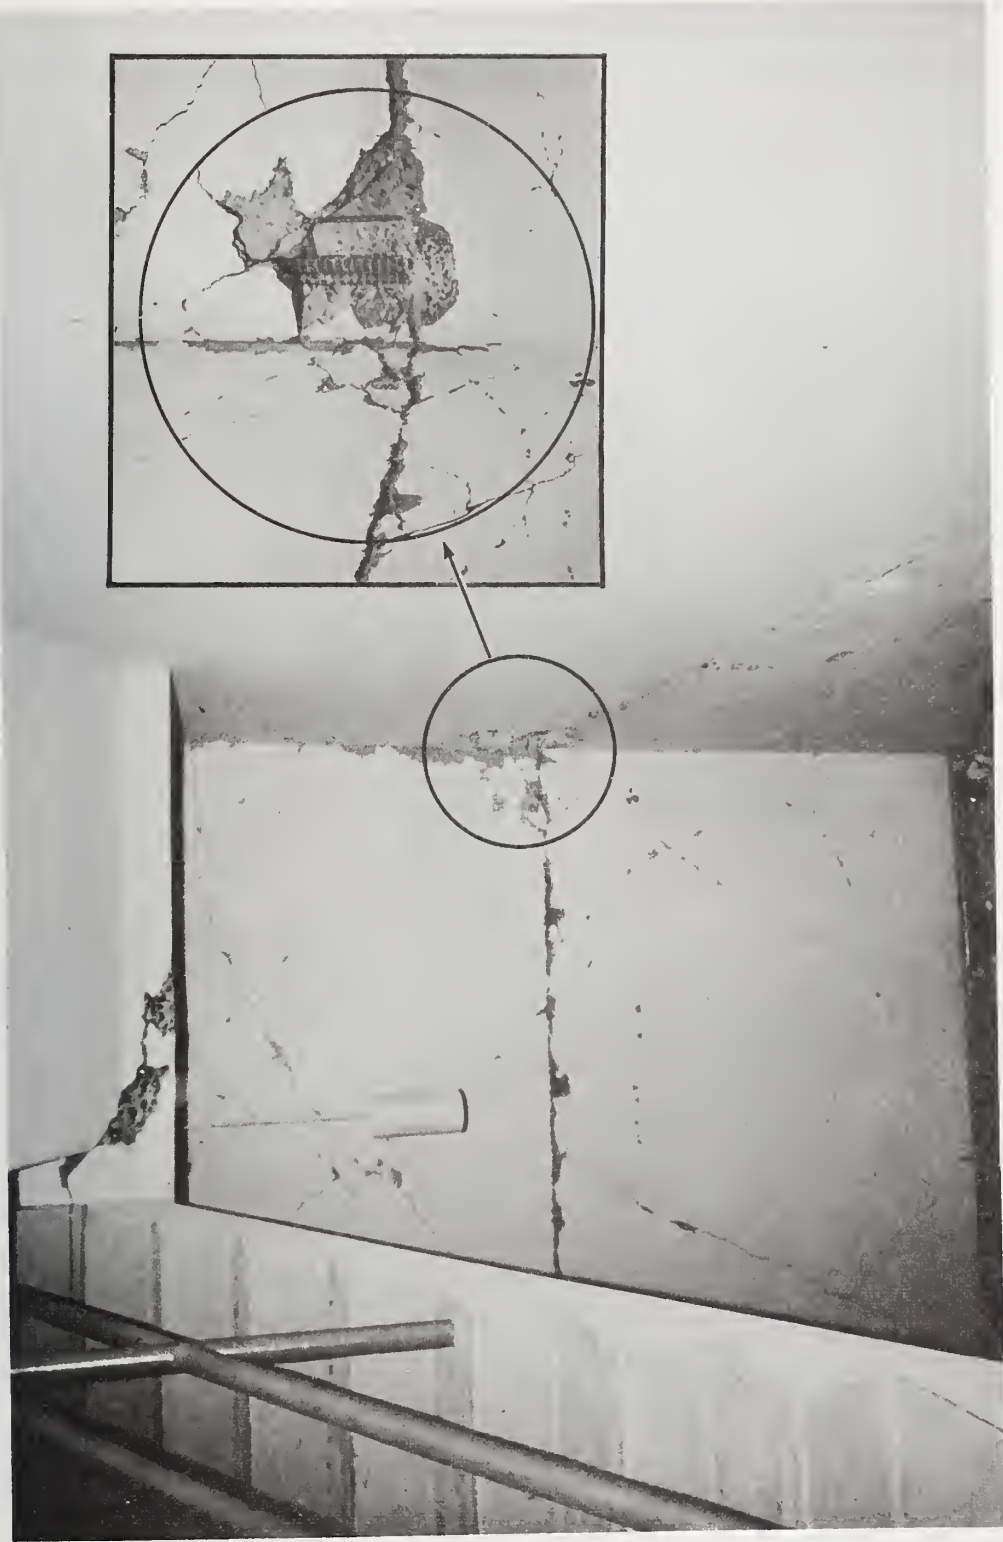
Figure 5.69 Diagonal and horizontal cracking in stairwell near the west end of the building. The horizontal crack is at the third floor.

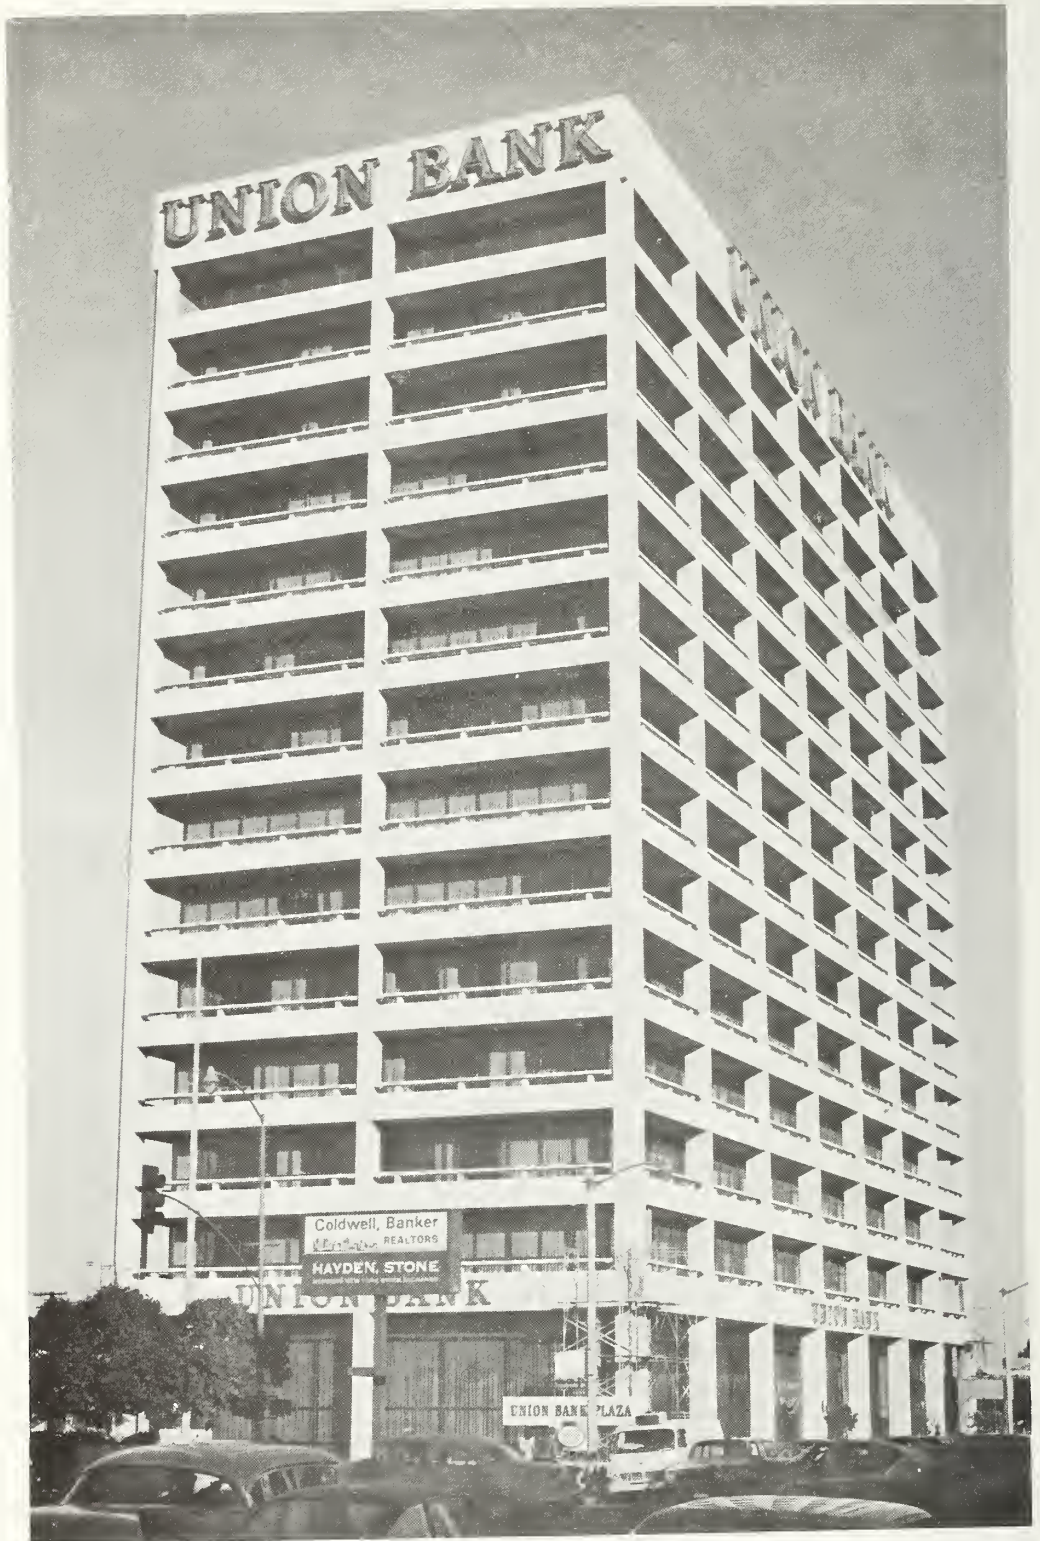
Figure 5.113 The south and west elevations of the thirteen-story Union Bank building. All four exterior corner columns in this reinforced concrete structure were cracked at the second floor level.

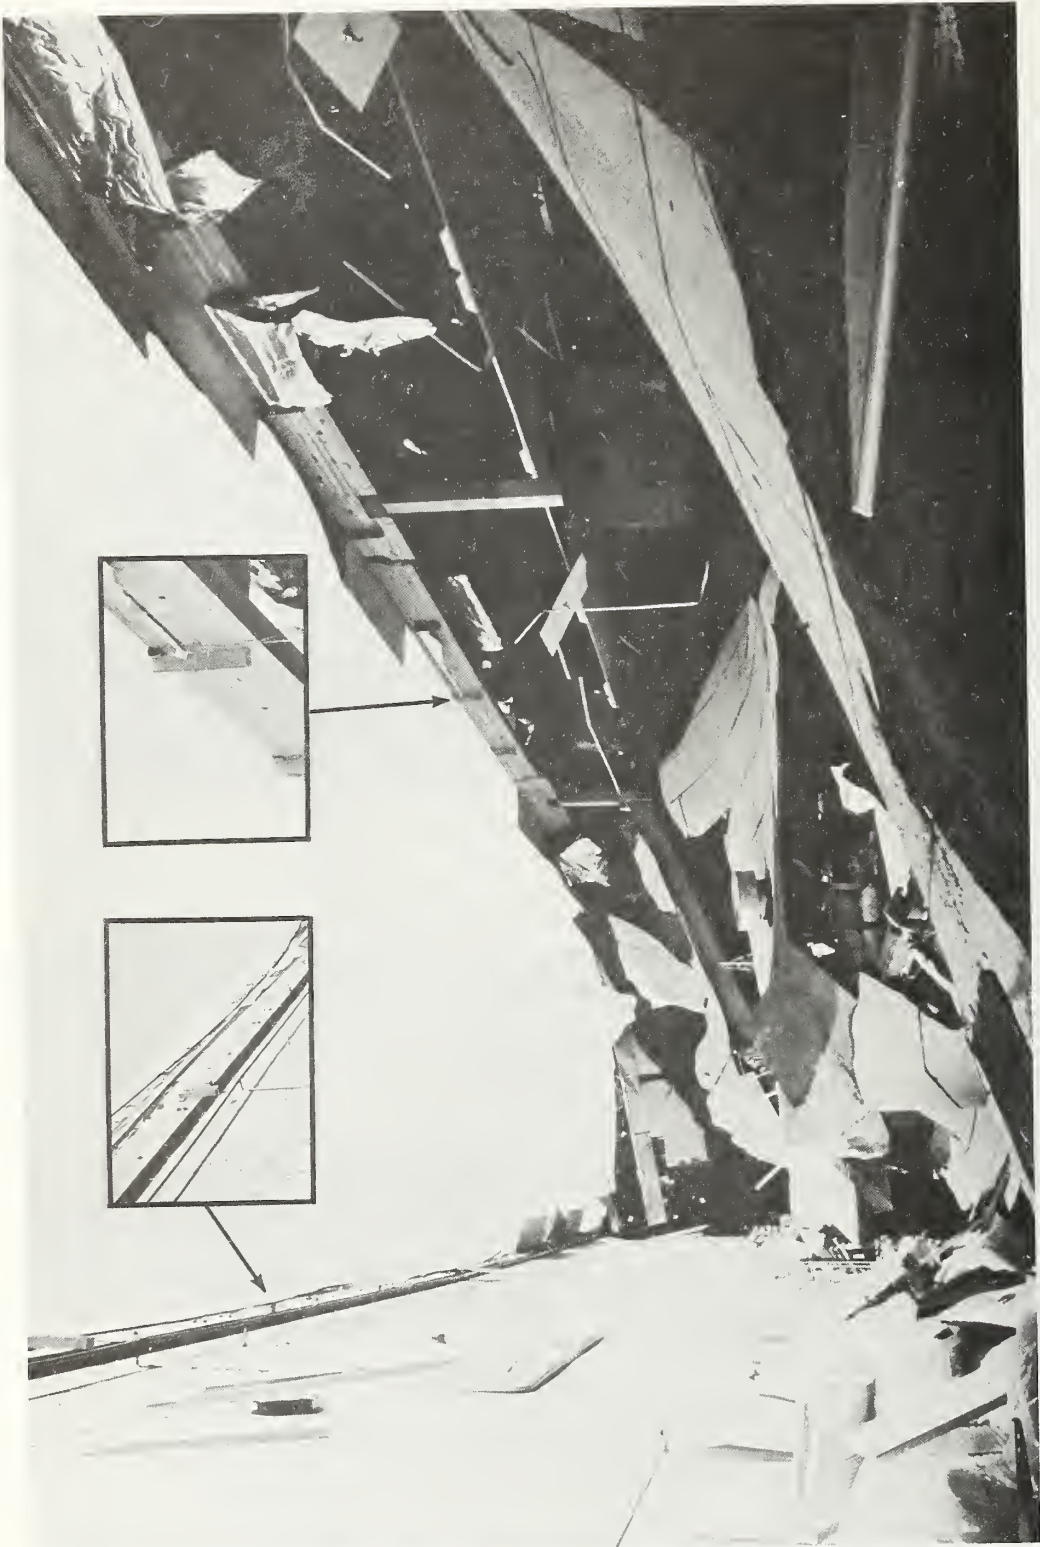
Figure 5.129 Collapsed roof structure at rear of Grants Department Store. Arrows indicate a wooden ledger fastened to the masonry wall (on the left) and metal beam hangers on the laminated wood girder (on the right).

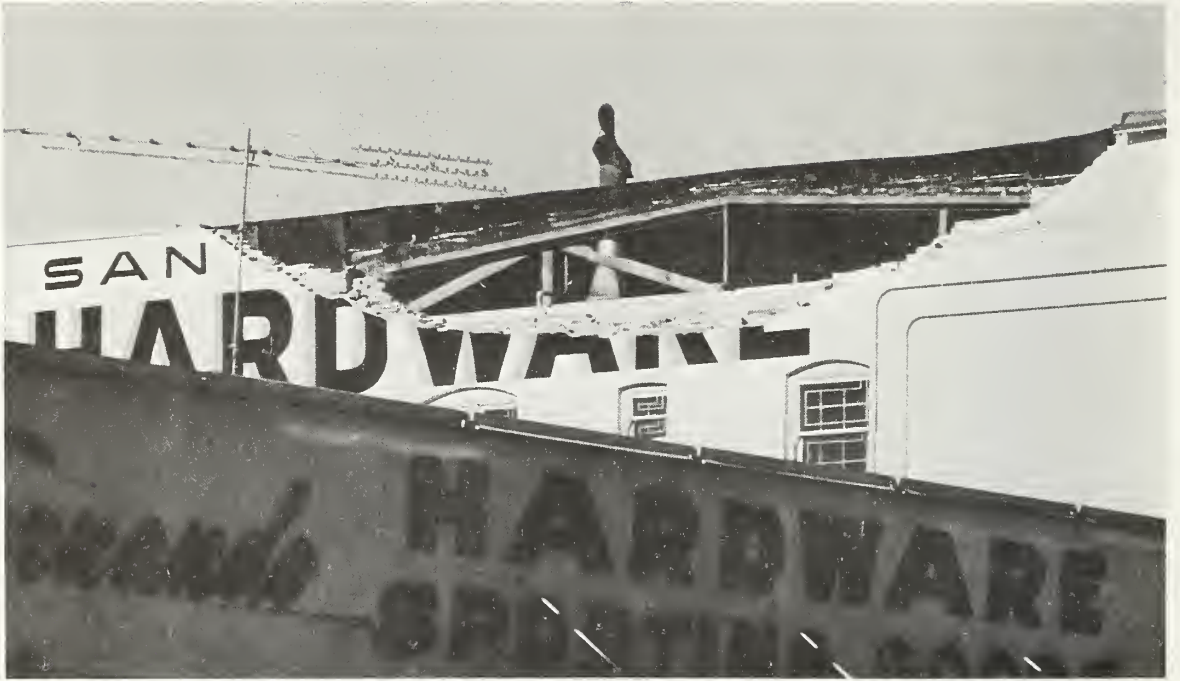
Figure 5.142 Damage to brick masonry parapet wall.

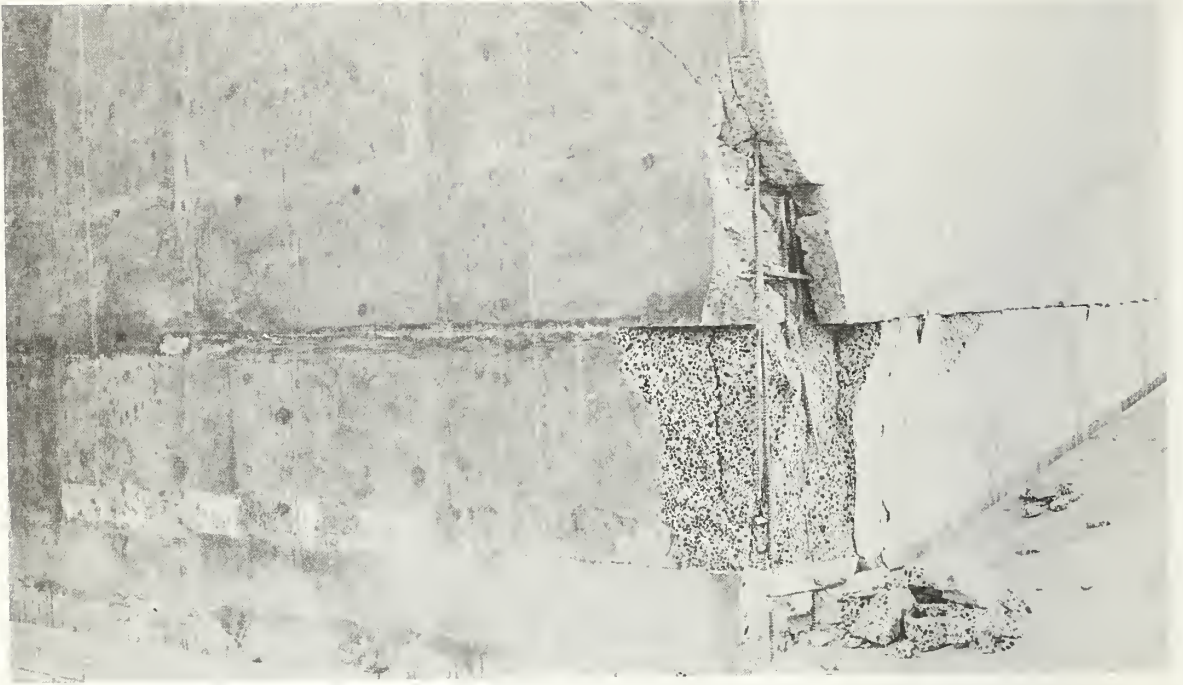
*Figure 5.178 Cracking and spalling at first floor
Corner of the Nethercutt Museum.*

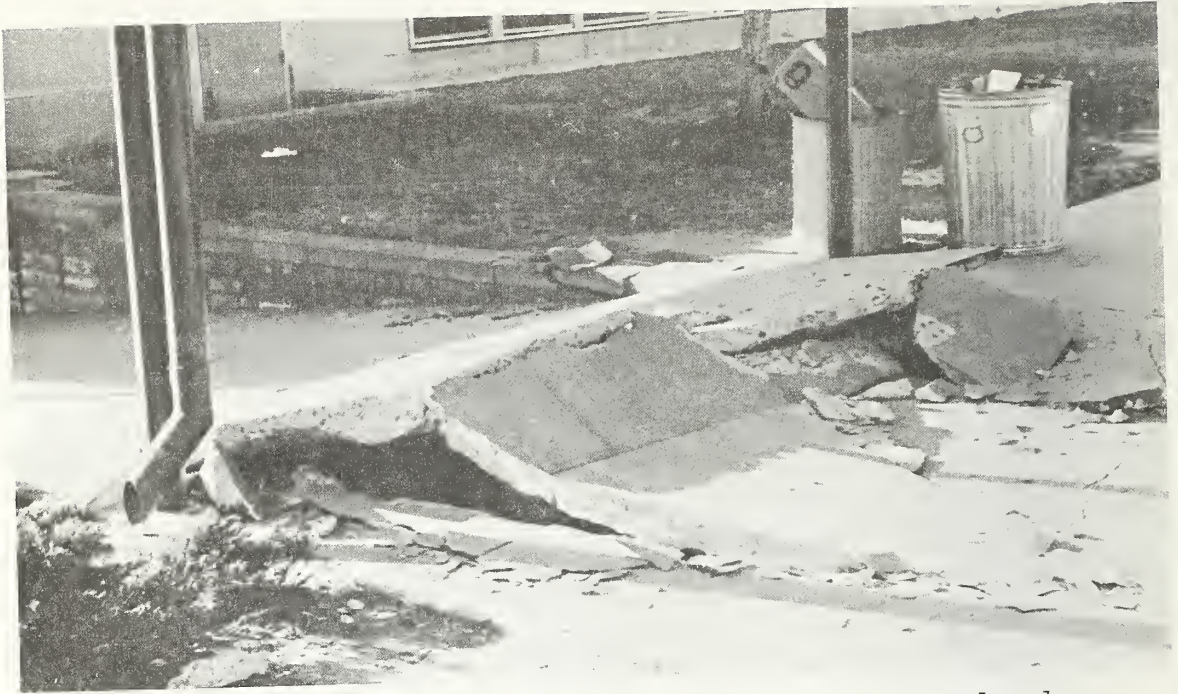
Figure 6.18 Slabs on grade were extensively cracked and buckled, Sylmar High School.

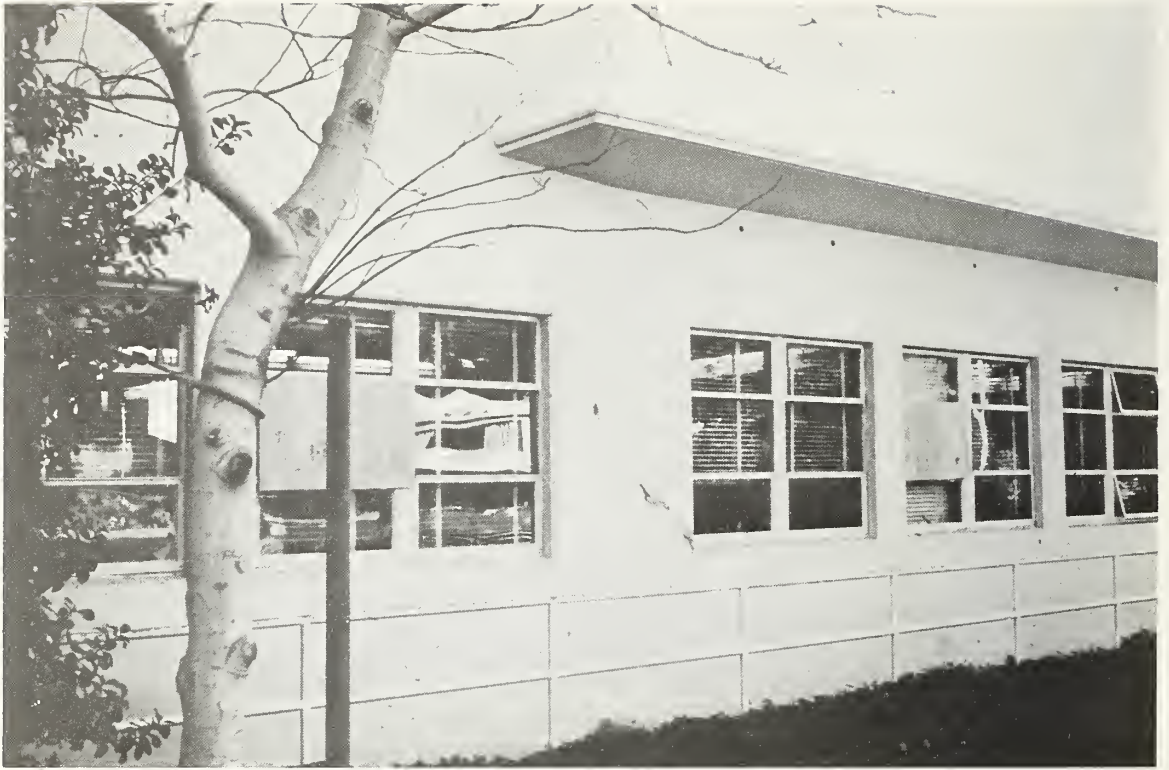
Figure 6.32 Cracked pier in north wall of administration wing, Crescenta Valley High School.
